Improving Compressed Air Quality And Countermeasures Against Leaks

This leaflet is an excerpt from an article written by Mr. Kouzou Matsuno of the Facilities Management Section, Takasago Administration Department, MITSUBISHI HITACHI POWER SYSTEMS, LTD. for the March 2014 issue of "The Energy Conservation", showcasing the results of the "SonicMan Survey" air/gas leak survey conducted by TTS LTD., an associate company of TLV CO., LTD.

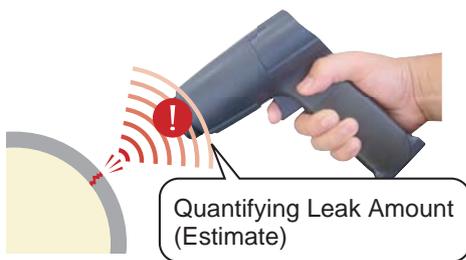
Fig 3. Diagnostic device

On investigating methods of accurately quantifying leak amount without relying on the five senses of the workers, we became aware of a method using ultrasonic waves that can detect even minute air leaks. From the fact that it would be difficult to fully deal with the investigation accuracy problem internally, we engaged a diagnosis service offered by TTS LTD., an associate company of TLV CO. LTD. that utilizes unique ultrasonic diagnostic technology. As Fig. 3 shows, this technology utilizes special diagnostic equipment to detect the ultrasonic waves generated when pressurized gas passes through a narrow passage (leak hole) and is discharged to a lower pressure area (the atmosphere, etc.), then identify the leak location and quantify (estimate) the amount of leakage.

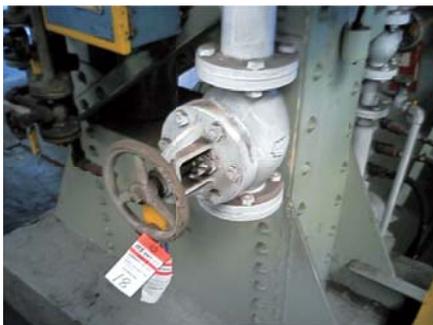
Photo 2. Tagging diagnostic results

After identifying the leak location, a tag showing

leakage amount as well as other data needed for aggregation, as shown in Photo 2, is affixed at the leak location to make clear diagnosis results.
